**Westwood Mill,
Linthwaite**

Building Recording
Volume 1

January 2004

Report No. 1129

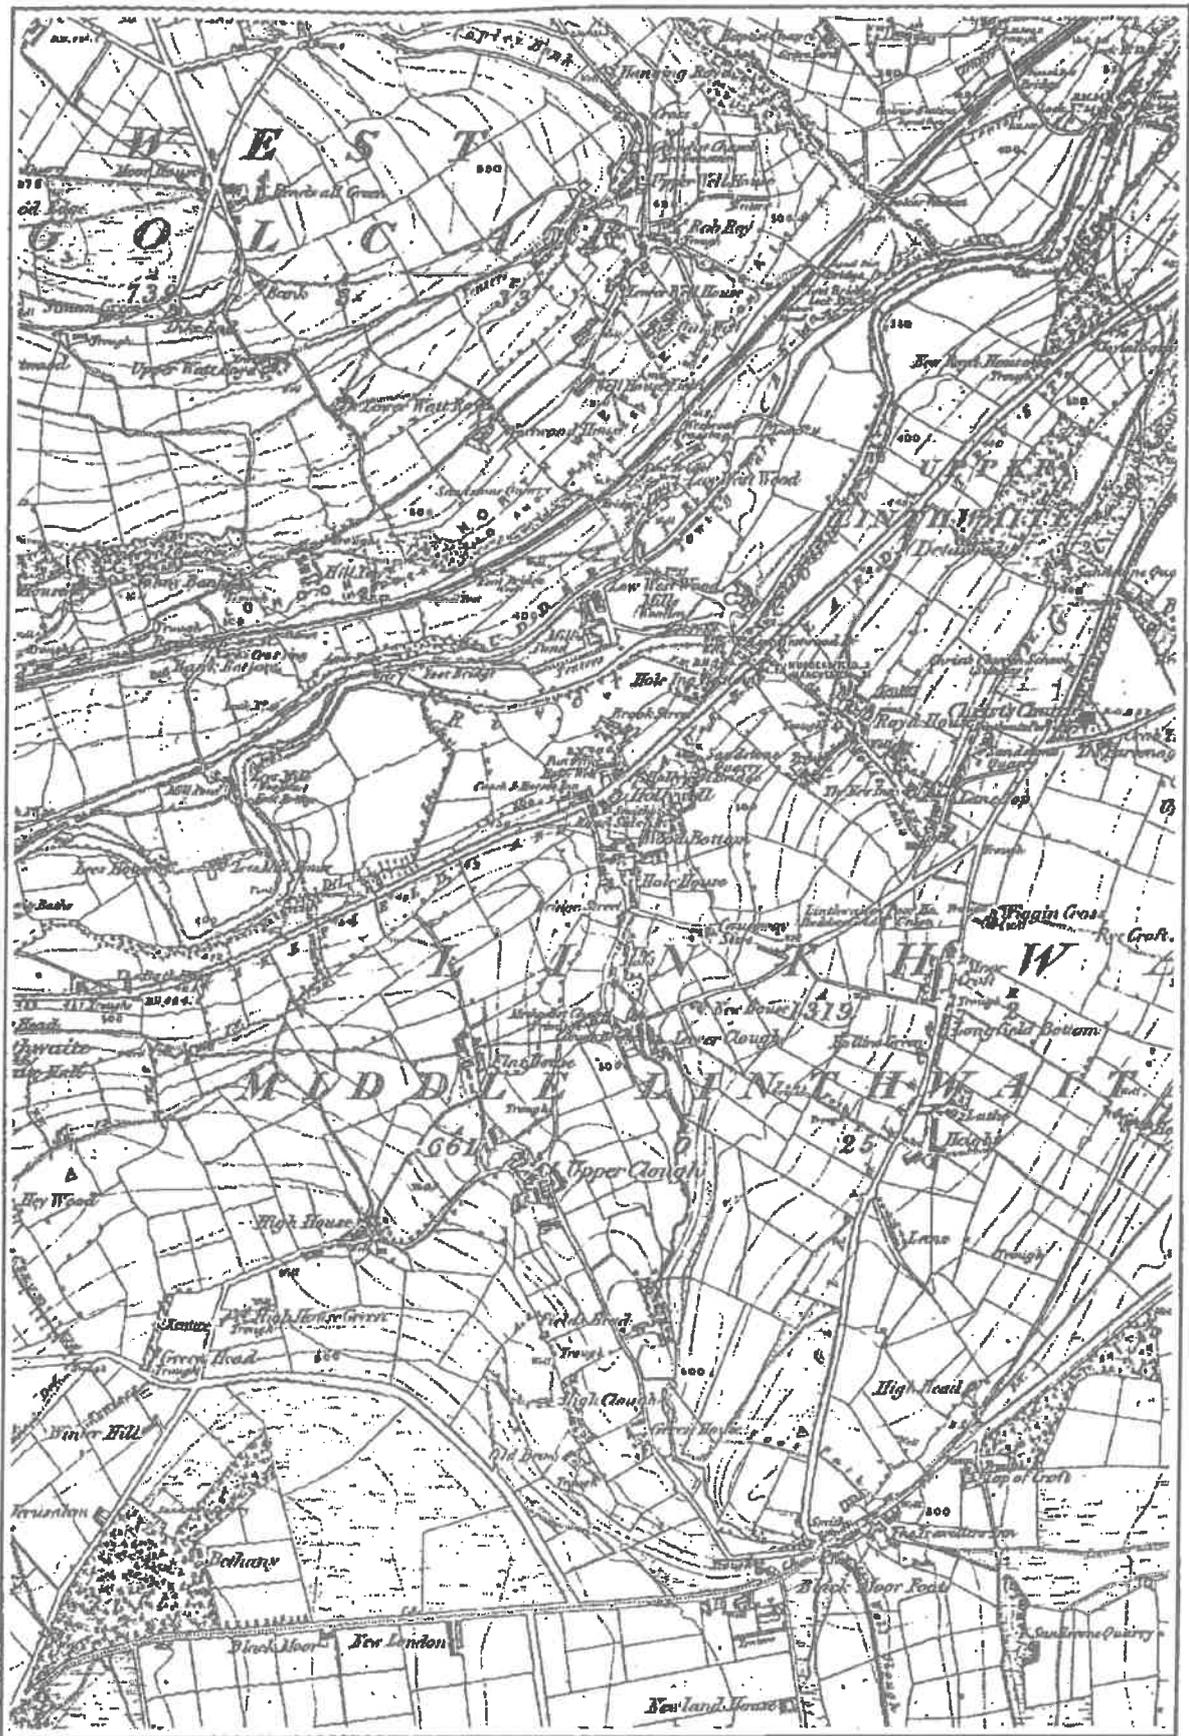
Fig. 4 Ordnance Survey 6 inch to 1 mile scale, sheet 260, 1854 (1848-51)

- 4.2 The first edition Ordnance Survey of 1854 (Fig. 4) shows a relatively well-developed group of buildings. Clearly from inspecting the buildings on the ground they belong to a number of different phases, several earlier than this date. The mill at this time is probably powered by a vertical steam engine housed in the engine house, with boiler-house to the south. Power is transmitted horizontally along the north-south axis. The Early building facing the canal may be a warehouse as there is no evidence here for power transmission

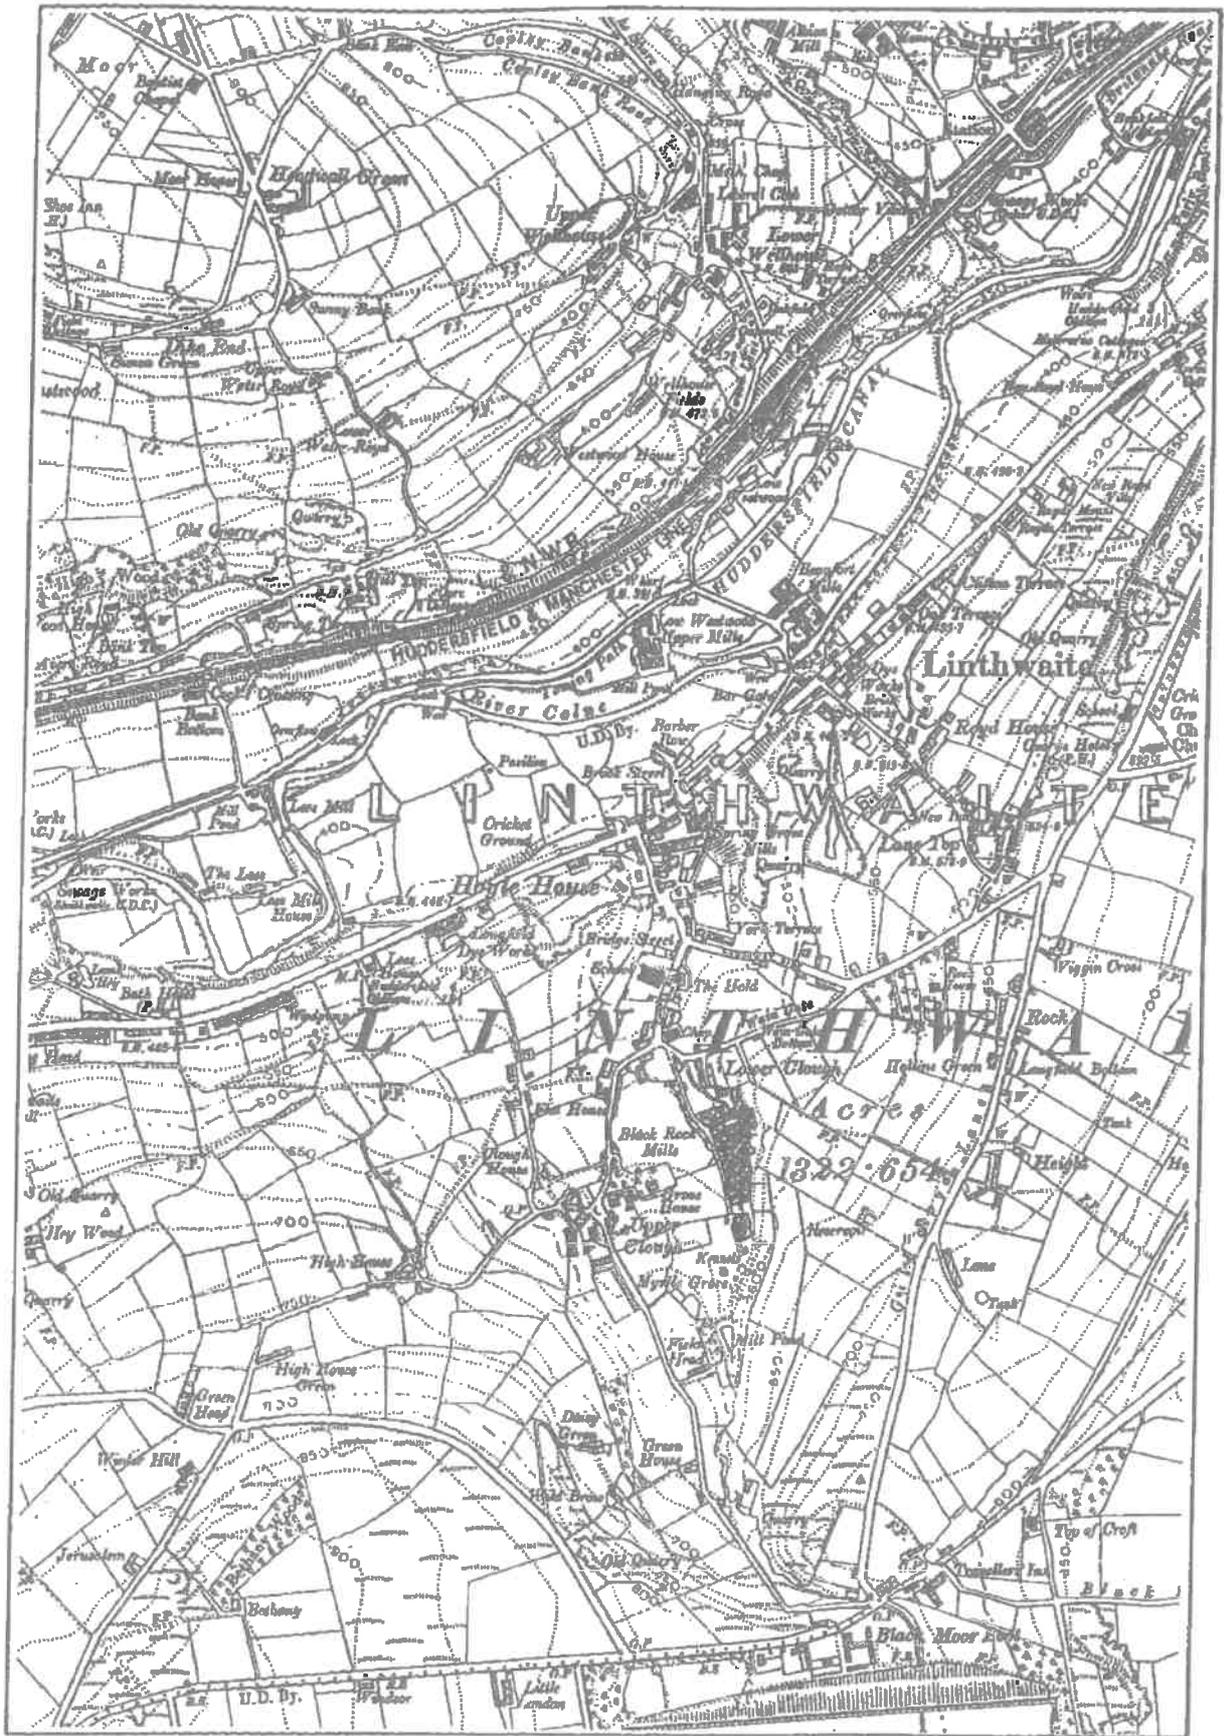
Fig. 6 Ordnance Survey 6 inch to 1 mile scale, sheet 260NW, 1908

- 3.5 Fig. 6 Ordnance Survey 6 inch to 1 mile scale, sheet 260NW, 1908. Now known as 'Low Westwood Upper Mills', a number of changes have been made. In the centre of the complex a large single storey shed has been built, whilst to the south, a two storey building, possibly for rag grinding, has been constructed incorporating part of an earlier structure.

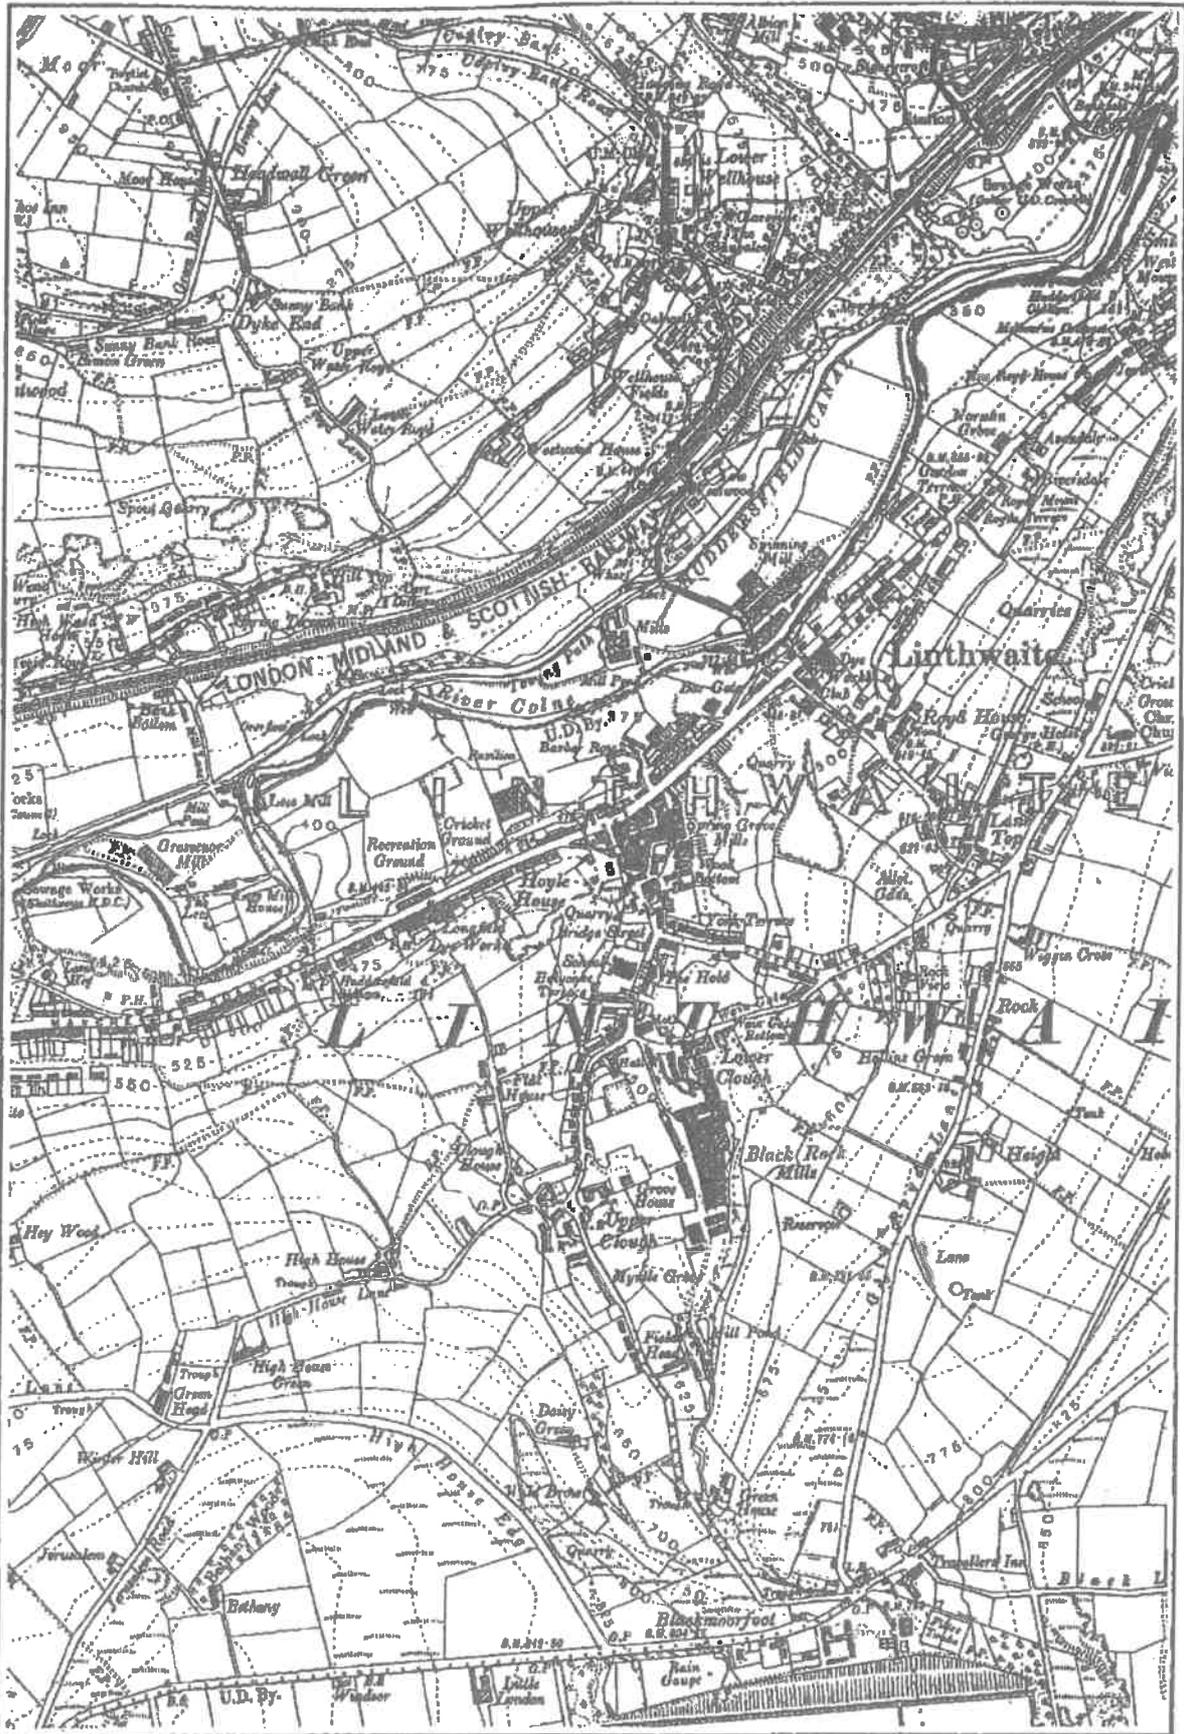
Fig. 7 Ordnance Survey 6 inch to 1 mile scale, sheet 260NW, 1929

- 3.6 Fig. 7 Ordnance Survey 6 inch to 1 mile scale, sheet 260NW, 1927. The buildings remain unchanged with the exception of the construction of a detached open-fronted brick shed of six bays at the south-east corner of the complex.

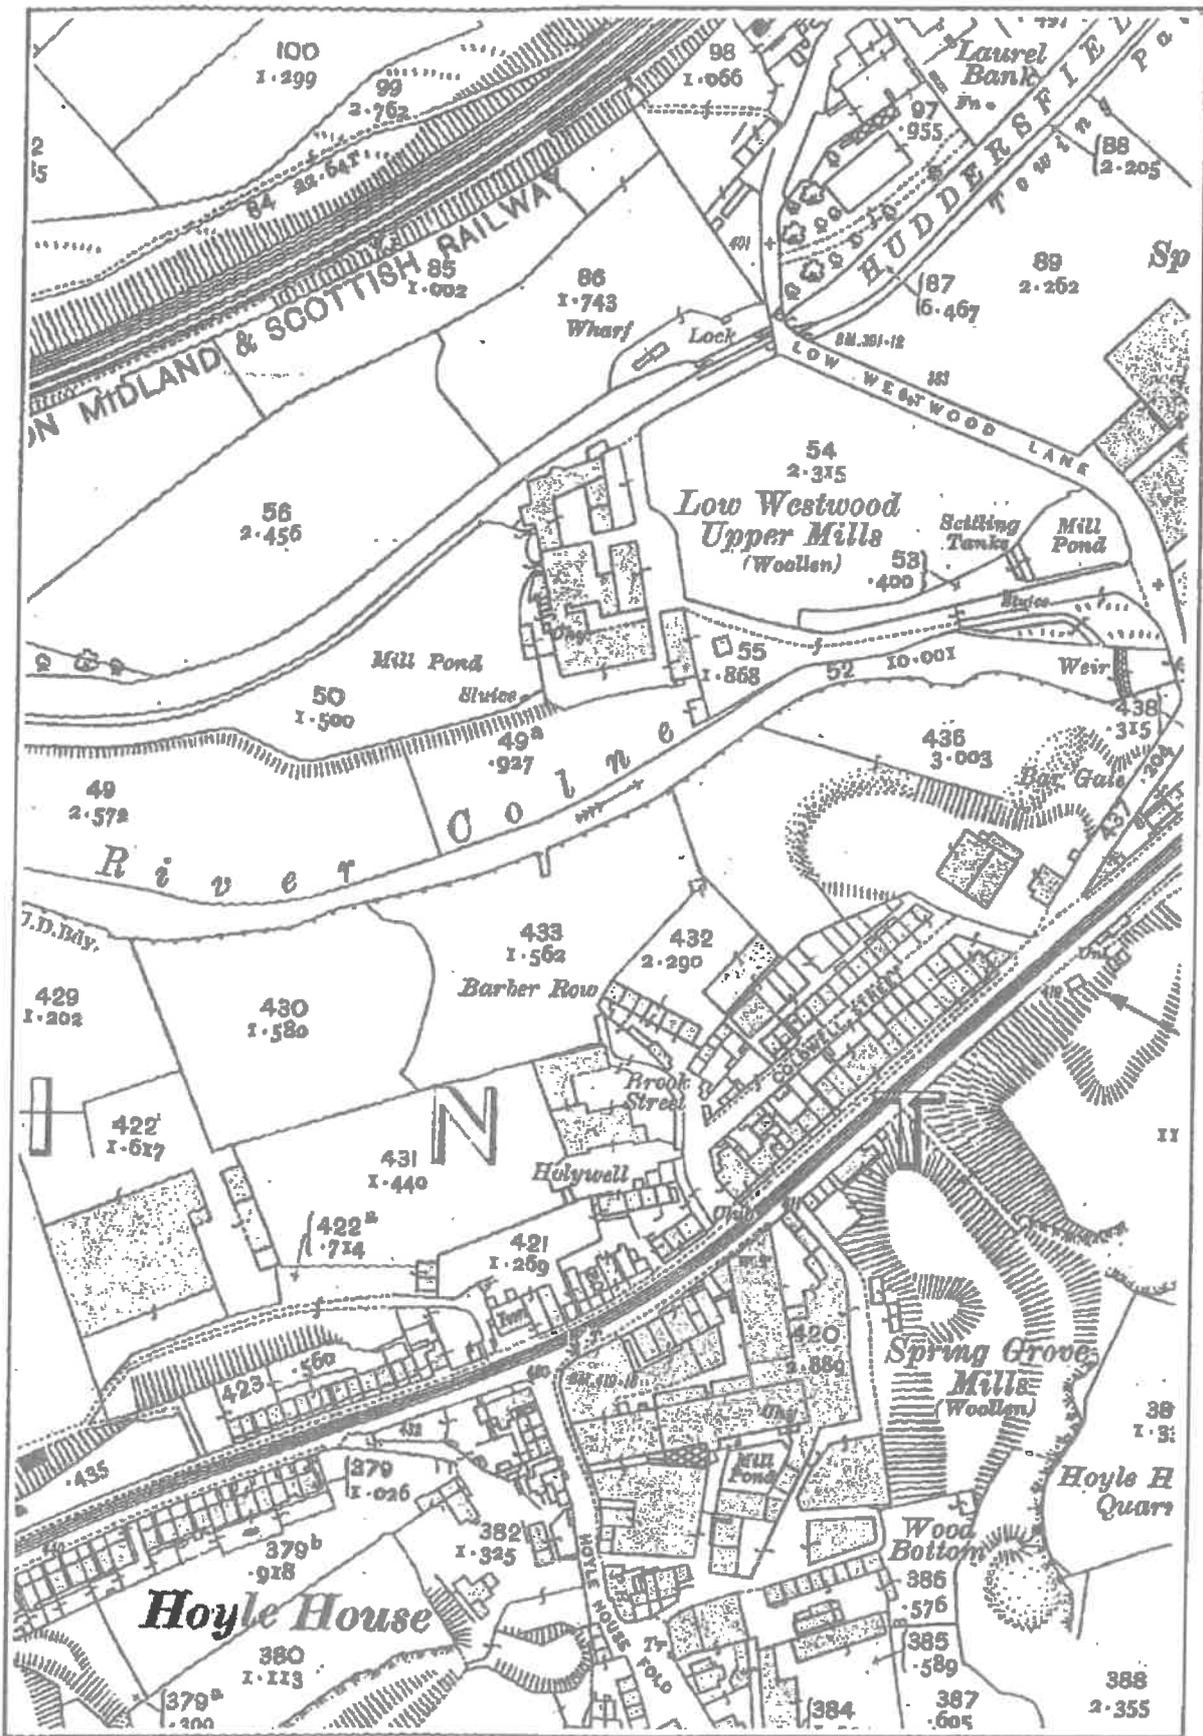
Fig. 8 Ordnance Survey 25 inch to 1 mile scale, sheet 260.1, 1932

- 3.7 Fig. 8 Ordnance Survey 25 inch to 1 mile scale, sheet 260.1, 1932. This larger scale plan is useful in that divisions between adjoining buildings are indicated. There is however, little new information. Interestingly, this plan makes it easier to understand the earlier water courses. It is apparent that the water from the mill pond that turned the early wheel (c. 1800) was then fed into the mill pond which powered Beaufort Mill to the east. The course of the channel for the later turbine appears to have been culveted and runs to the south and east of the complex, rejoining the Colne downstream above a small weir.

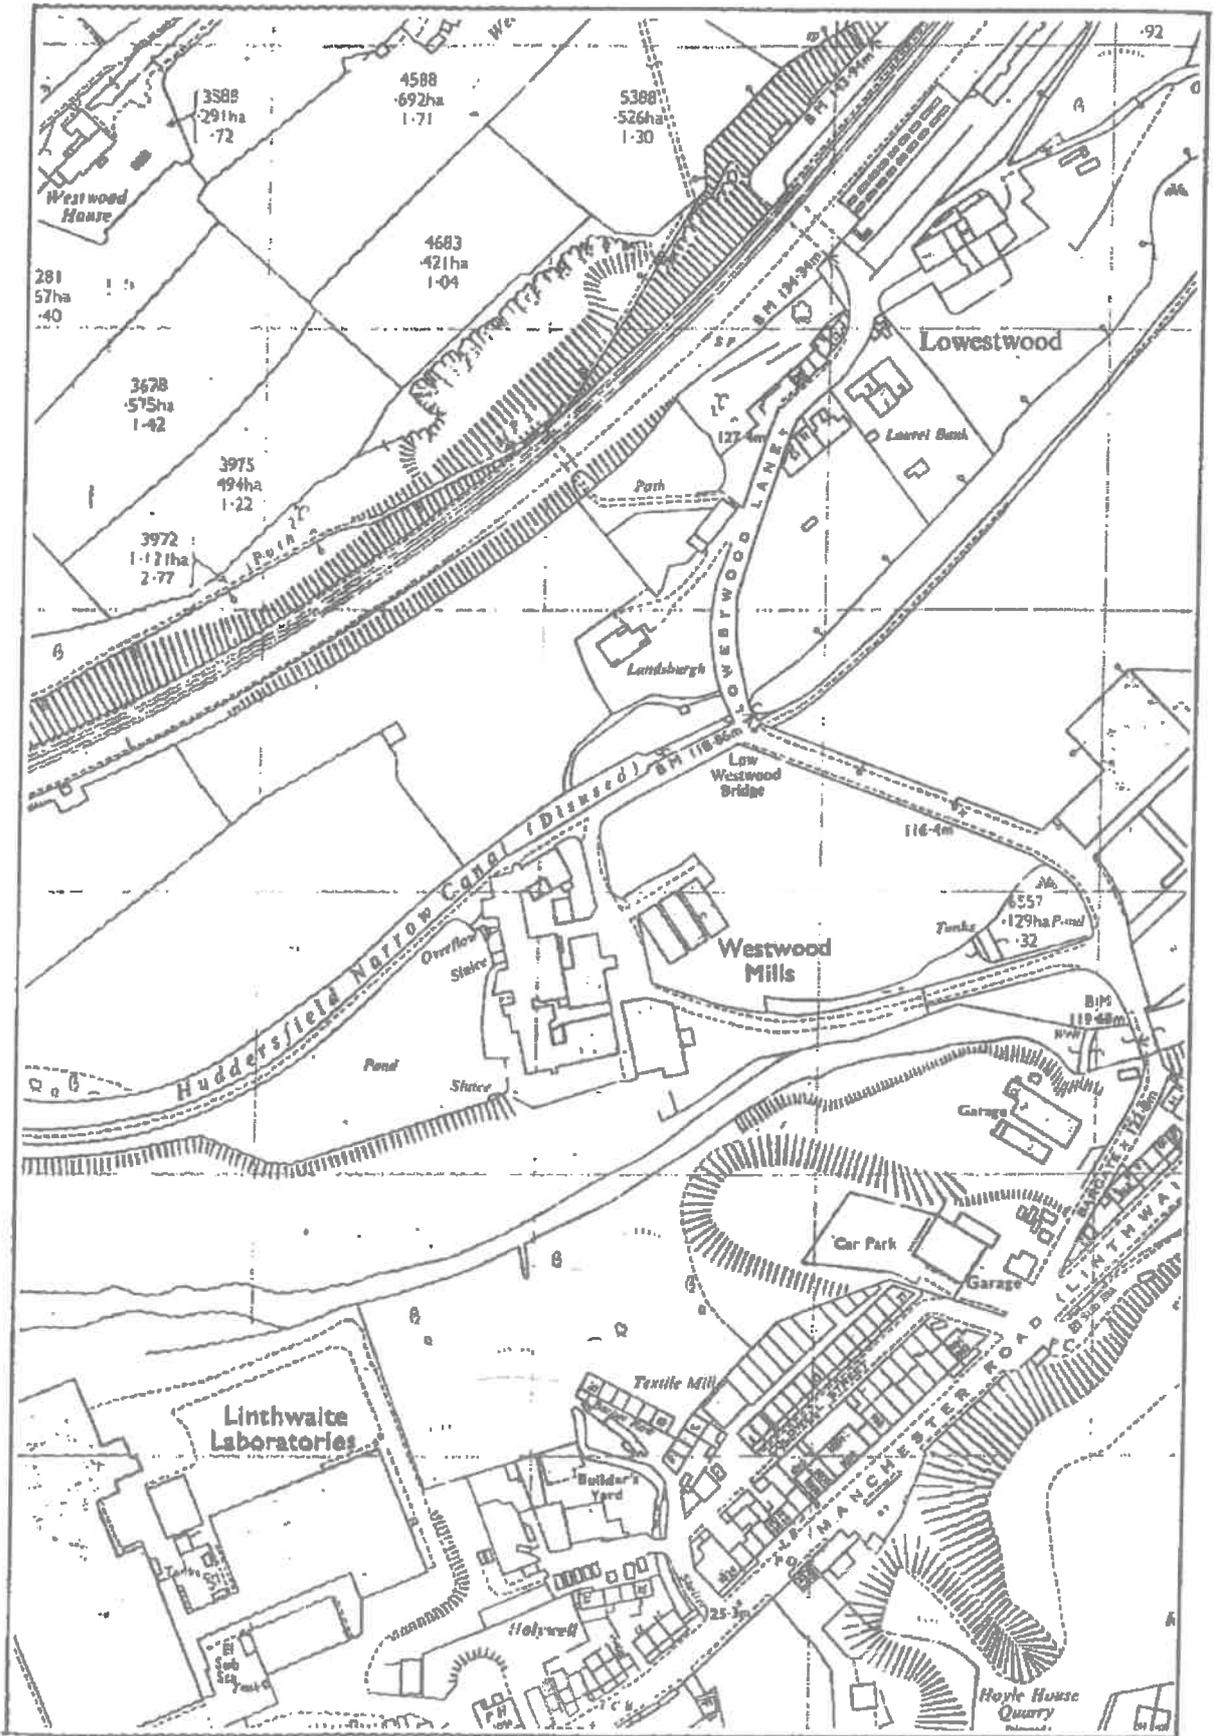
Fig. 10 Ordnance Survey 1:2500 scale, sheet SE 0814 0914, 1977

- 3.8 Fig. 9 Ordnance survey 6 inch to 1 mile scale, sheet 260NW, 1948. Now changes shown to building plans on this map.
- 3.9 Fig. 10 Ordnance Survey 1:2500 scale, sheet SE 0814 0914, 1977. The main changes are an addition to the east of a brick shed (possibly a garage) to the rear of the open fronted six-bay shed noted in 3.6, and the siting of three Nissan huts (WWII salvage?) to the east of the central building range.

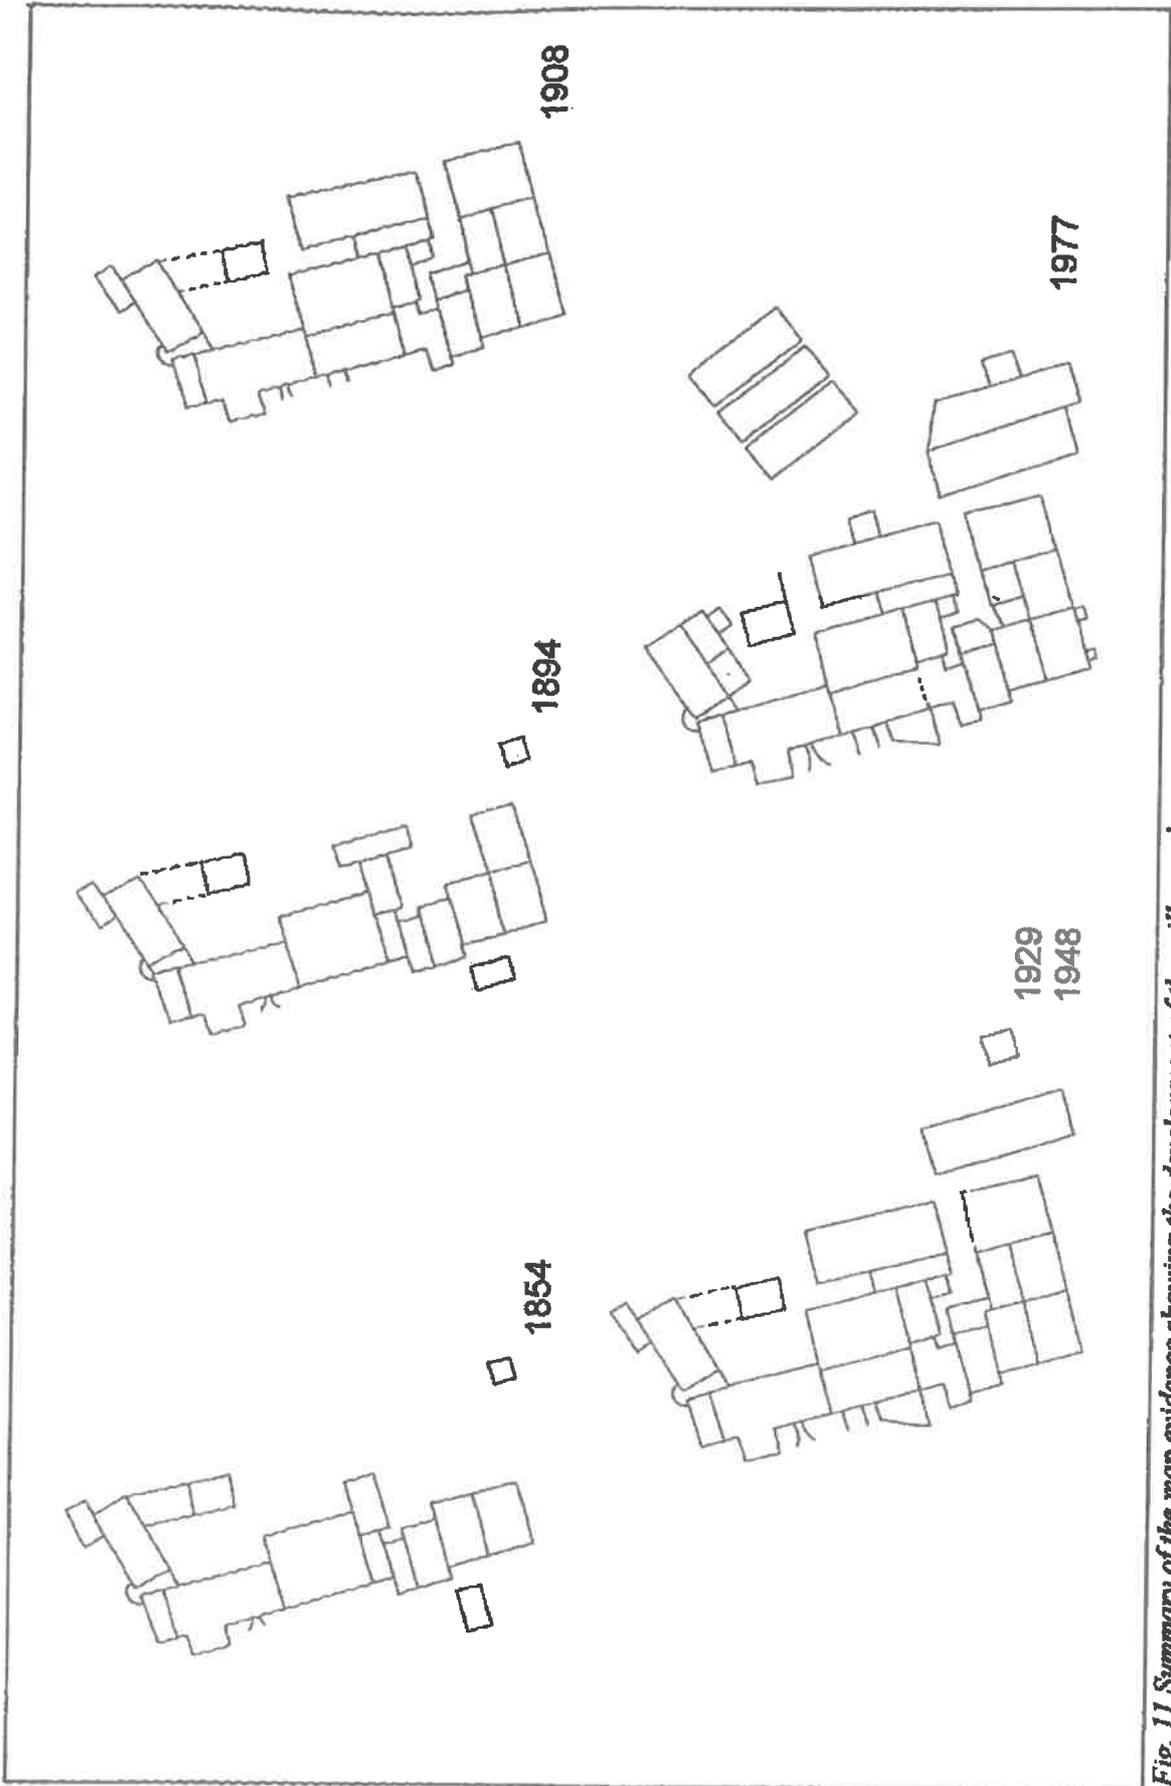
Fig. 11 Summary of the map evidence showing the development of the mill complex

- 4.1 The information contained in the above series of maps is summarised in Fig. 11. Only certain maps provided relevant information.

- 4.3 The Ordnance Survey plan of 1894 shows only a few minor changes. The building between B and C (Fig. 11) has been removed. A small shed has been added to the central area. Additional buildings have been constructed to the south.

- 4.4 1908. Evidence shown for the introduction of water turbine power. Major grow and addition of new buildings to the south and west. It is possible that the central jack-arched building is new or refurbished at this time.

- 4.5 Maps dated 1929 and 1948 show very similar information. By this date the site is almost fully developed with the addition of buildings in the south-east corner.

- 4.6 The final map shows the site in 1977. Additional buildings have been added to the south-east, and to the centre-east. Some minor changes noted to some of the more established structures.

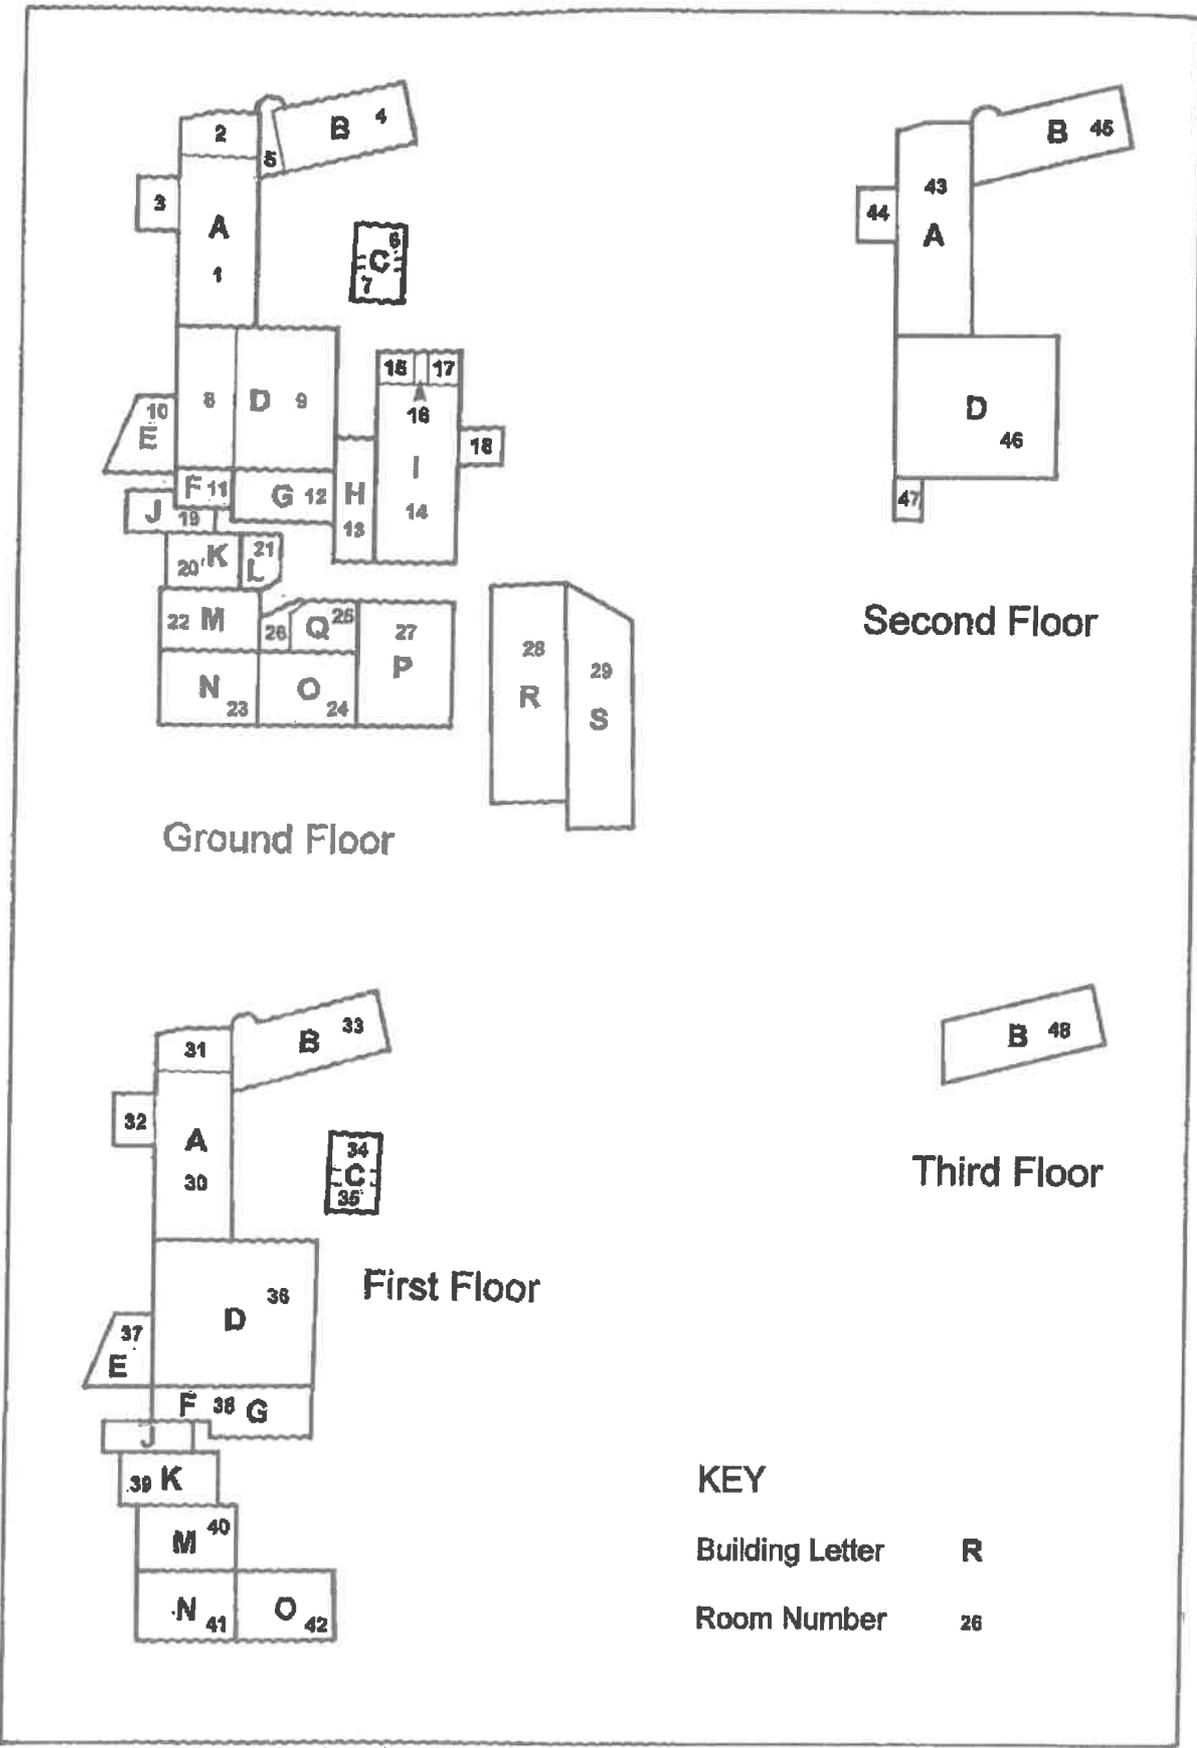
Fig. 12 Key plan showing the building and room references used in the report

- 5.1 To aid identification, each building has been allocated a letter, and each room a sequential number. Descriptions are by building, not by floor. See Fig. 12.

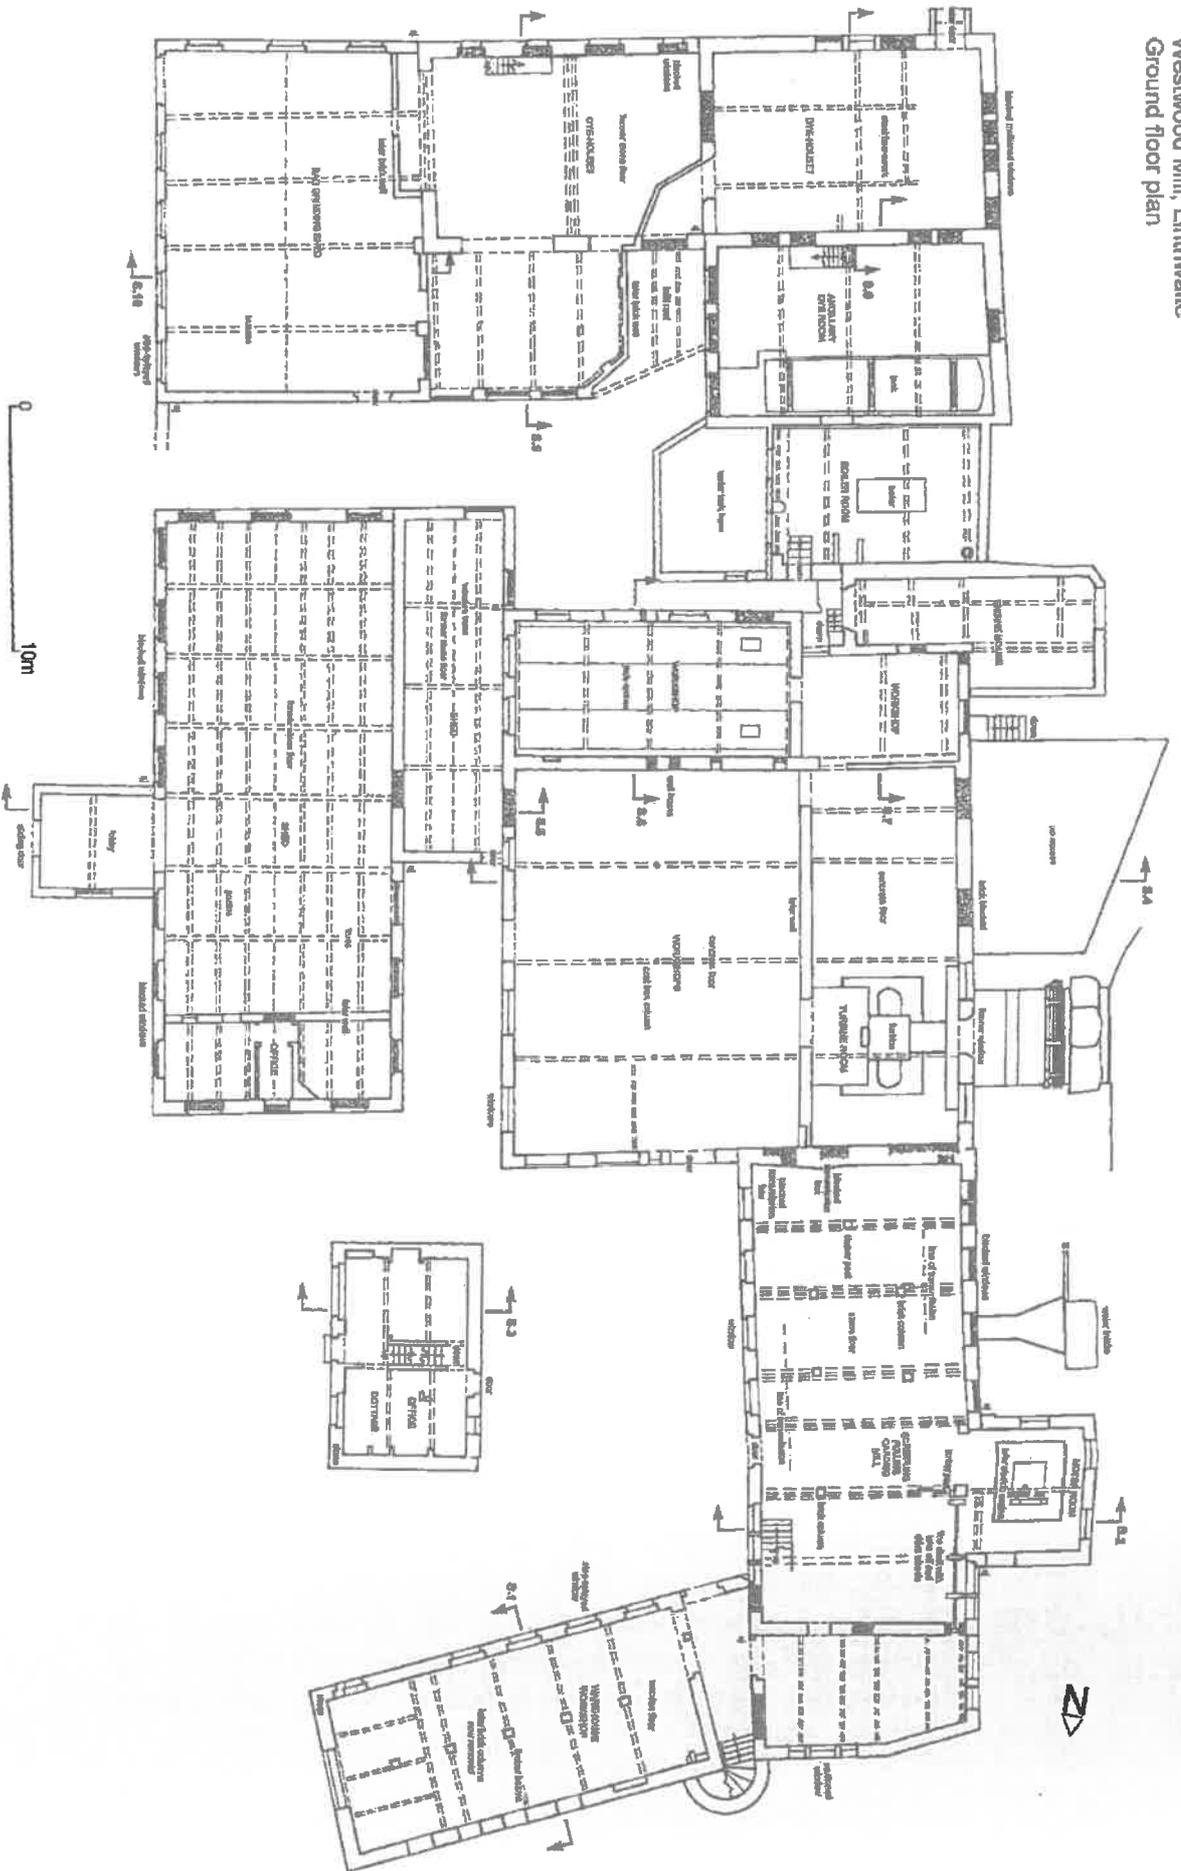
Fig. 13 Ground floor plan

- 5.2 Building A, ground floor (Fig. 13.) comprising three rooms, numbered 1-3. Construction is entirely of stone. Room 1, aligned north-south, has gross dimensions of 20m by 9m. The building is of seven bays and has three floors. Externally, the eastern façade (Fig. 34.) faces a courtyard and has windows at each bay with the exception of the southern most which has taking-in doors. Access is on the ground floor, through an original door in the third bay from the north, and later in a secondary door in the second bay from the north. Room two forms a slightly later addition to the building (room 31 on the first floor). The external north facing elevation (Fig. 31.) has blocked windows at ground floor level, a half blocked mullioned

Room one on the ground floor (Fig. 13.) has six substantial beams supporting the floor above. Beneath each beam are positioned two tension rods, stitching the outer walls together. The floor of the room is of timber. Recent brick piers support the beams in several places. Within bays one and two from the north are the remains of line shafting and take off wheels. These formerly connected to an electric engine situated in the motor room (room three). Windows on the west side, south of the motor room are blocked, as is a window on the east side in bay one and an original connecting door to room two. Within the southern wall are a number of blocked wall boxes. Room two to the north, of slightly later date is entered by its secondary door. The structure is of five bays and has a three light mullioned window in its northern wall, and a two light window to the west. A door in the eastern wall connects with the later stair passage for building B. A blocked opening to the north may have been original. A flight of wooden stairs in bay two of room one lead to the first floor.

Ground floor, room five. A stepped doorway leads to the stair passage, inserted between buildings A and B, with stone steps leading up to the first floor of B. Room four, having gross dimensions of approximately 16mx7m is of six bays. On the south side are four stepped windows in the first four bays, with an altered stepped window in the last bay. On the north side, what may have been window openings in bays three to six are blocked. A semi blocked fireplace can be seen in bay two. The stone constructed building has a wooden floor. A series of brick piers running down the centre of the room supporting the beams of the floor above. Spiral stairs lead to the first floor.

Ground floor (Fig. 13). Two rooms divided by centrally placed stairs. Two doors, each opening to a separate room. To the north, room 6 has a fireplace and the remains of a side cupboard, with two beams supporting the upper floor. It is lit by windows to the east and west. Room 7, to the south, again has a fireplace and side cupboard, with a single window to the east. Access to the upper floor is by wooden stairs from this room.

Ground floor (Fig. 13). The original almost square space is later divided into two rooms, 8 and 9. Room 8 houses the later turbine (9270/3) In the northern wall (9270/7) a brick blocked semi-circular opening may have been the original water wheel recess associated with building A. Blocked wall box and window can be seen further east in this wall (9270/12) The eastern wall (9270/14) is a later insertion of thin coursed stone, with one blocked door, and one door to the south joining with room 9. The southern wall has been part rebuilt in brick. The western wall has four blocked windows (9270/3, 9270/5). The turbine, which is constructed of riveted sections of iron, takes water from the west, which drives through the transposed chamber, emerges to the south, and is channelled away. The floor of the room is of concrete, the ceiling is concrete supported on iron beams. Room 9, twice the area of 8, has a row of three central supporting cast iron columns with bolting heads, each supporting an iron beam (9265/2). The eastern wall is an original part

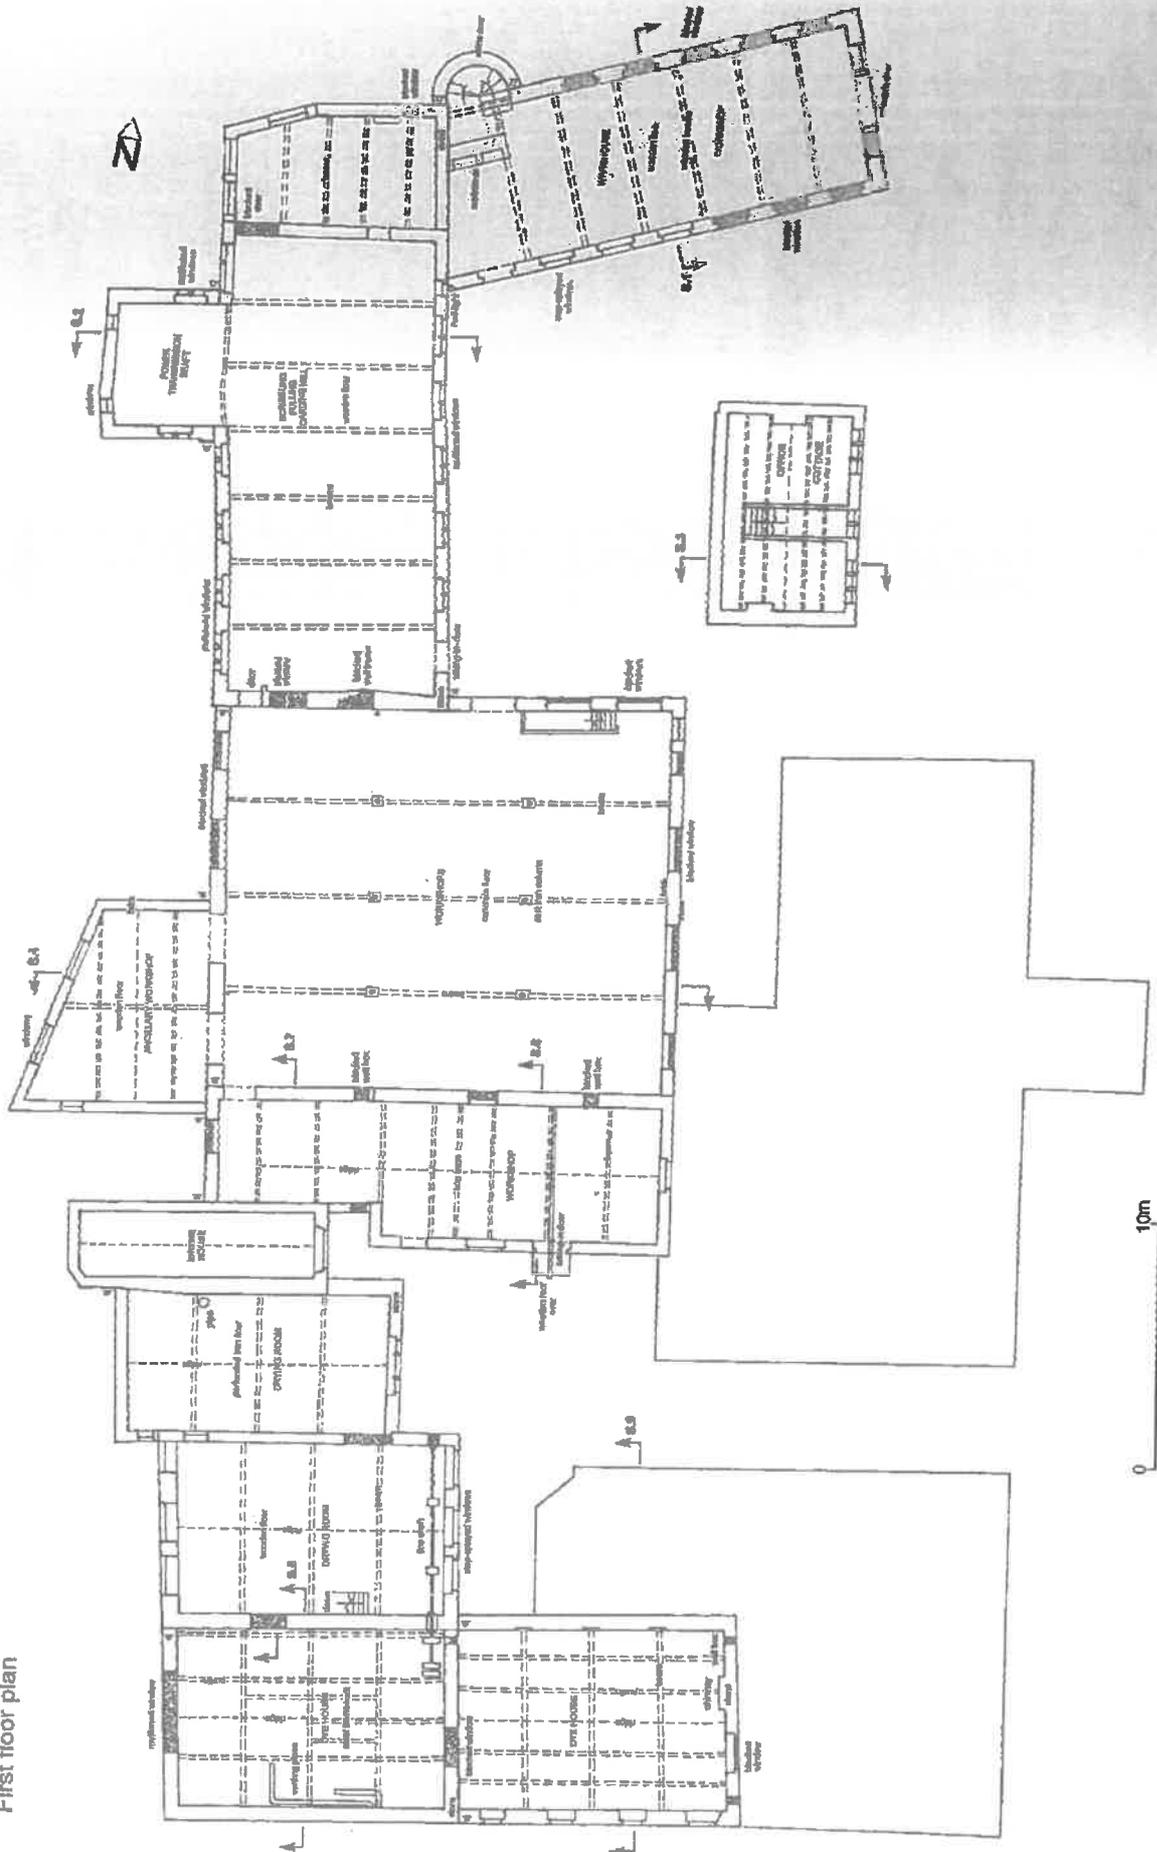
Fig. 15 First floor plan

Room thirty (Fig. 15.) is again of seven bays with mullioned windows and an end taking in door facing the eastern courtyard. On the western side are a series of two and three light mullioned windows. The later power transmission shaft, room thirty two has opposed two light mullioned windows in its side walls and two more recent windows in its western wall. The beams supporting the second floor have tension rods similar to those visible on the ground floor. Blocked wall boxes are visible in the southern wall, as is blocked mullioned window and a later door communicating with building D. In the northern wall is an original blocked door, and a later door leading to room thirty one. This later addition shares the same footprint as room two, has a wide window in its western wall and two windows in the northern wall, one of which is blocked. The floors of both rooms are of timber. Access to the second floor is made via the spiral staircase between buildings A and B.

This floor (Fig. 15.) of seven bays has step-splayed windows facing south, with the end three stone blocked, and the first one having a taking-in door. On the northern side similar windows in bays three to seven are all blocked. Near the head of the stairs are a pair of stone cupboards lined in steel. Beams between each bay support the floor above, which can be reached up the spiral stairs. The second floor (Fig. 16.) is of similar plan to that below. In the northern wall is a single wide window at bay five, and one of standard size at bay seven. A flight of wooden stairs adjacent to the west wall leads to the third floor. This floor (Fig. 17, room 48) is open to its rafters. It follows the same seven bay plan and has a taking in door inserted over an earlier triple mullioned window in the eastern wall. The arrangement of windows facing south is similar to that on the lower floors. A series of mortices between bays 1-4 may imply altered tie beam positions. The floor is of wood. The roof (see Fig. 18) is supported on six trusses. Each has a tie-beam set into the side walls supporting principal rafters which meet at the apex

First floor (Fig. 15). Room 34 to the north has a blocked fireplace and a three part window to the east. Room 35 to the south has the same. The stairs are lit by a single two part east facing window. The roof (Fig. 20) is supported on trusses comprising soft-wood tie-beams with principal rafters and collar. The tie beams rest on wall plates, with the principal rafters supporting two morticed purlins to either side. There is a small ridge piece at the apex.

First floor (Fig. 15) can only be reached through building A at second floor level, and then down a later flight of stairs. The floor, room 36, is open and uninterrupted. Two rows of cast iron columns can be seen (9268/3) supporting iron beams above. In the northern wall (9268/9) can be see a blocked window and low arched opening with blocked wall box above. Interestingly, a roof scar visible in this elevation may have belonged to the early wheelhouse. To the east later stairs encased with brick cause the two windows in this area to be blocked. The eastern elevation is original to the building D phase, and has four similar sized blocked windows. To the south, the wall is shared with the earlier building G which has a number of blocked wall boxes along its length. The western wall originally had four windows. The two to the north have been blocked, whilst the two to the south have been altered to provide openings to the later building E. Stairs lead to the second floor.
