**Westwood Mill,
Linthwaite**

Building Recording
Volume 1

January 2004

Report No. 1129

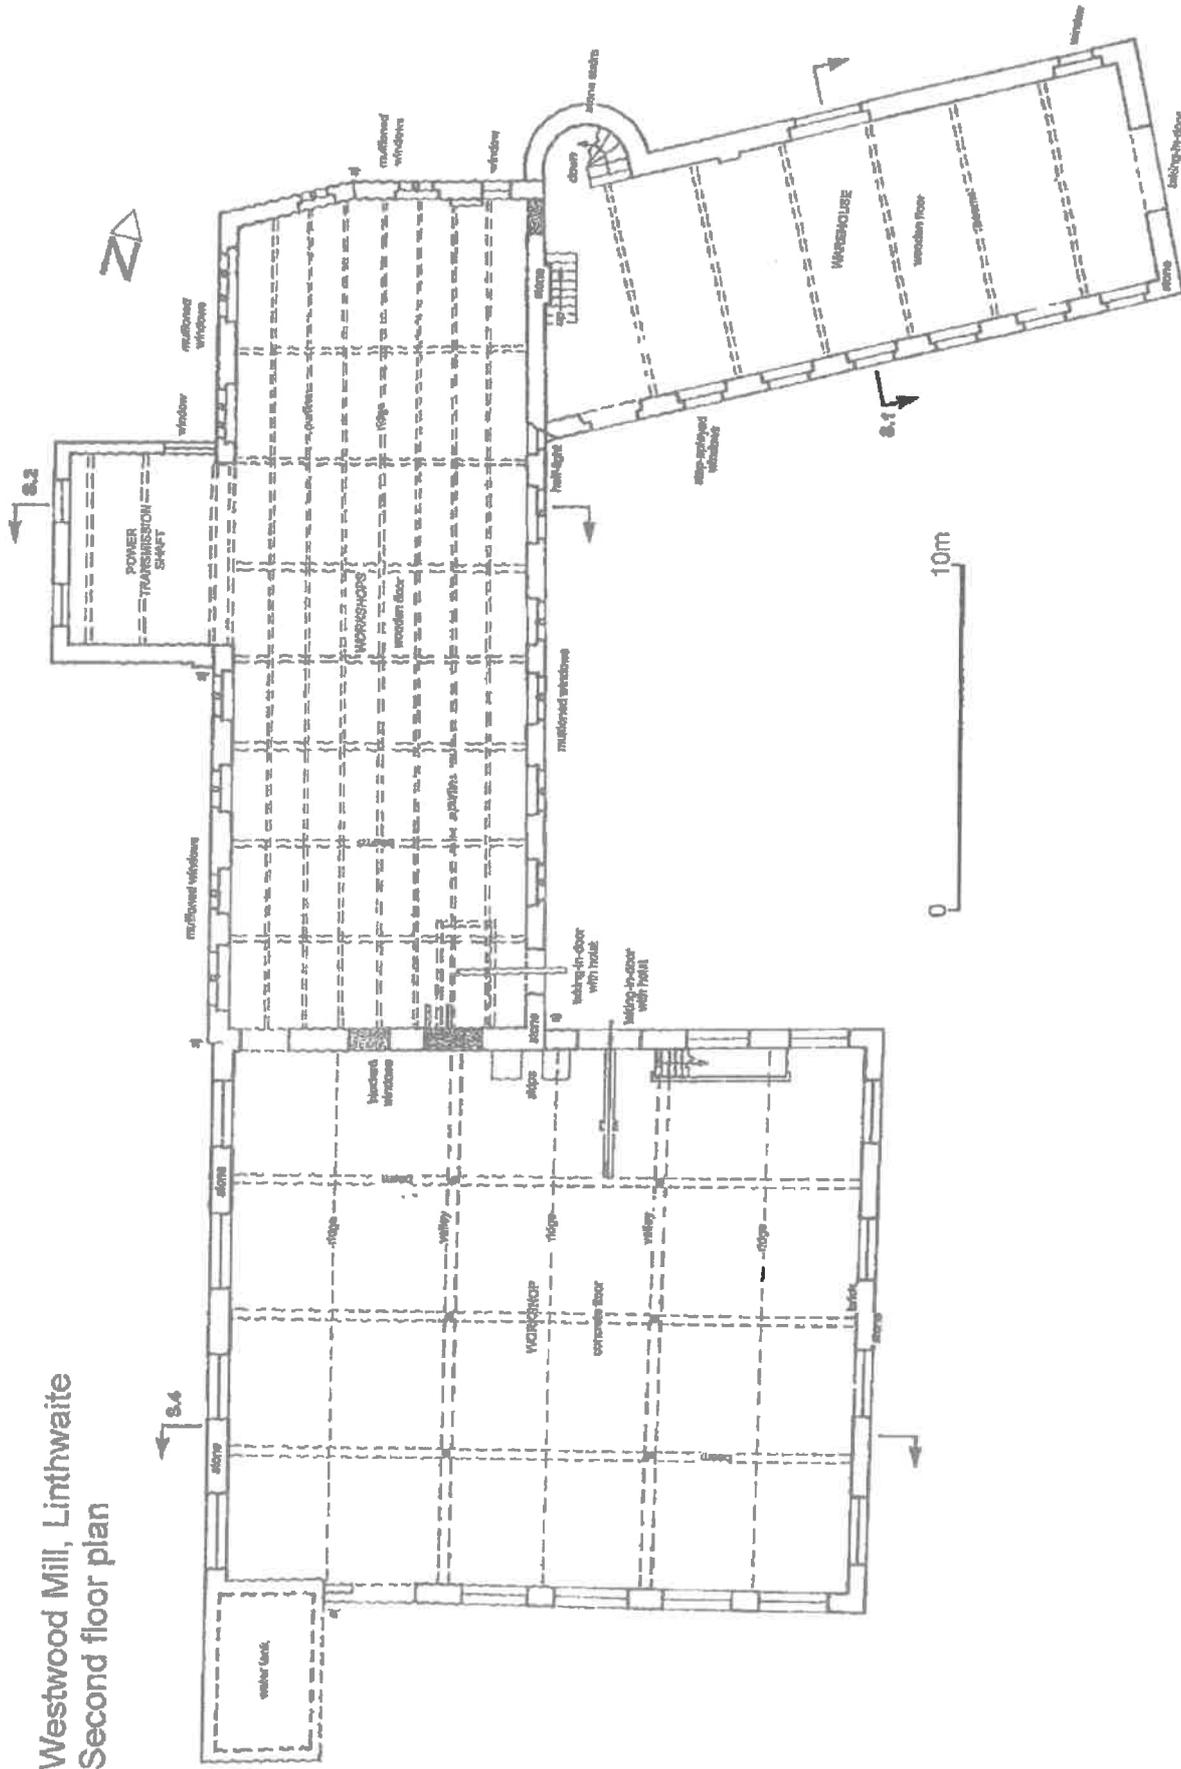
Fig. 16 Second floor plan

The second floor (Fig. 16.) comprises one space of eight bays (room forty three). It originally had two light mullioned windows at each bay with three light mullioned windows in bays one and two from the north. The northern wall has a pair of two light mullioned windows with a slightly later single light window. The southern wall has two blocked windows and a later doorway to building D. Over the taking in door in bay eight is a hoist. The later power transmission shaft has two windows in its western wall and one in the northern wall.

Second floor (Fig. 16). An open area, exposed to the rafters, with the roof removed, 9267/13. The northern wall (9267/14) is mostly composed of the southern gable of building A. The pitch of the earlier roof line in stone contrasts with the brick additions of the later roofs. Within the early gable can be seen (possibly) two stone blocked two part mullioned windows, with an arch headed window above. The door to the west is clearly later. Two small brick built skips or chutes are placed in the centre of the wall, to the east of which is the brick enclosed stair down. A taking in door between has a hoist above (9297/16). The eastern and western walls are undistinguished., both having a regular arrangement of four segmental arched windows. The southern wall (9267/13) has five segmental arched windows. In the western bay the stone of the earlier water tower contrasts with the brick of the later building. The tower supports an iron tank (9268/2). The roof (9267/18) is of three pitches supported two rows of three columns at the valleys. All trusses are identical (Fig. 21) comprising Vitruvian style king posts and struts supporting principal rafters with single purlins to each side.

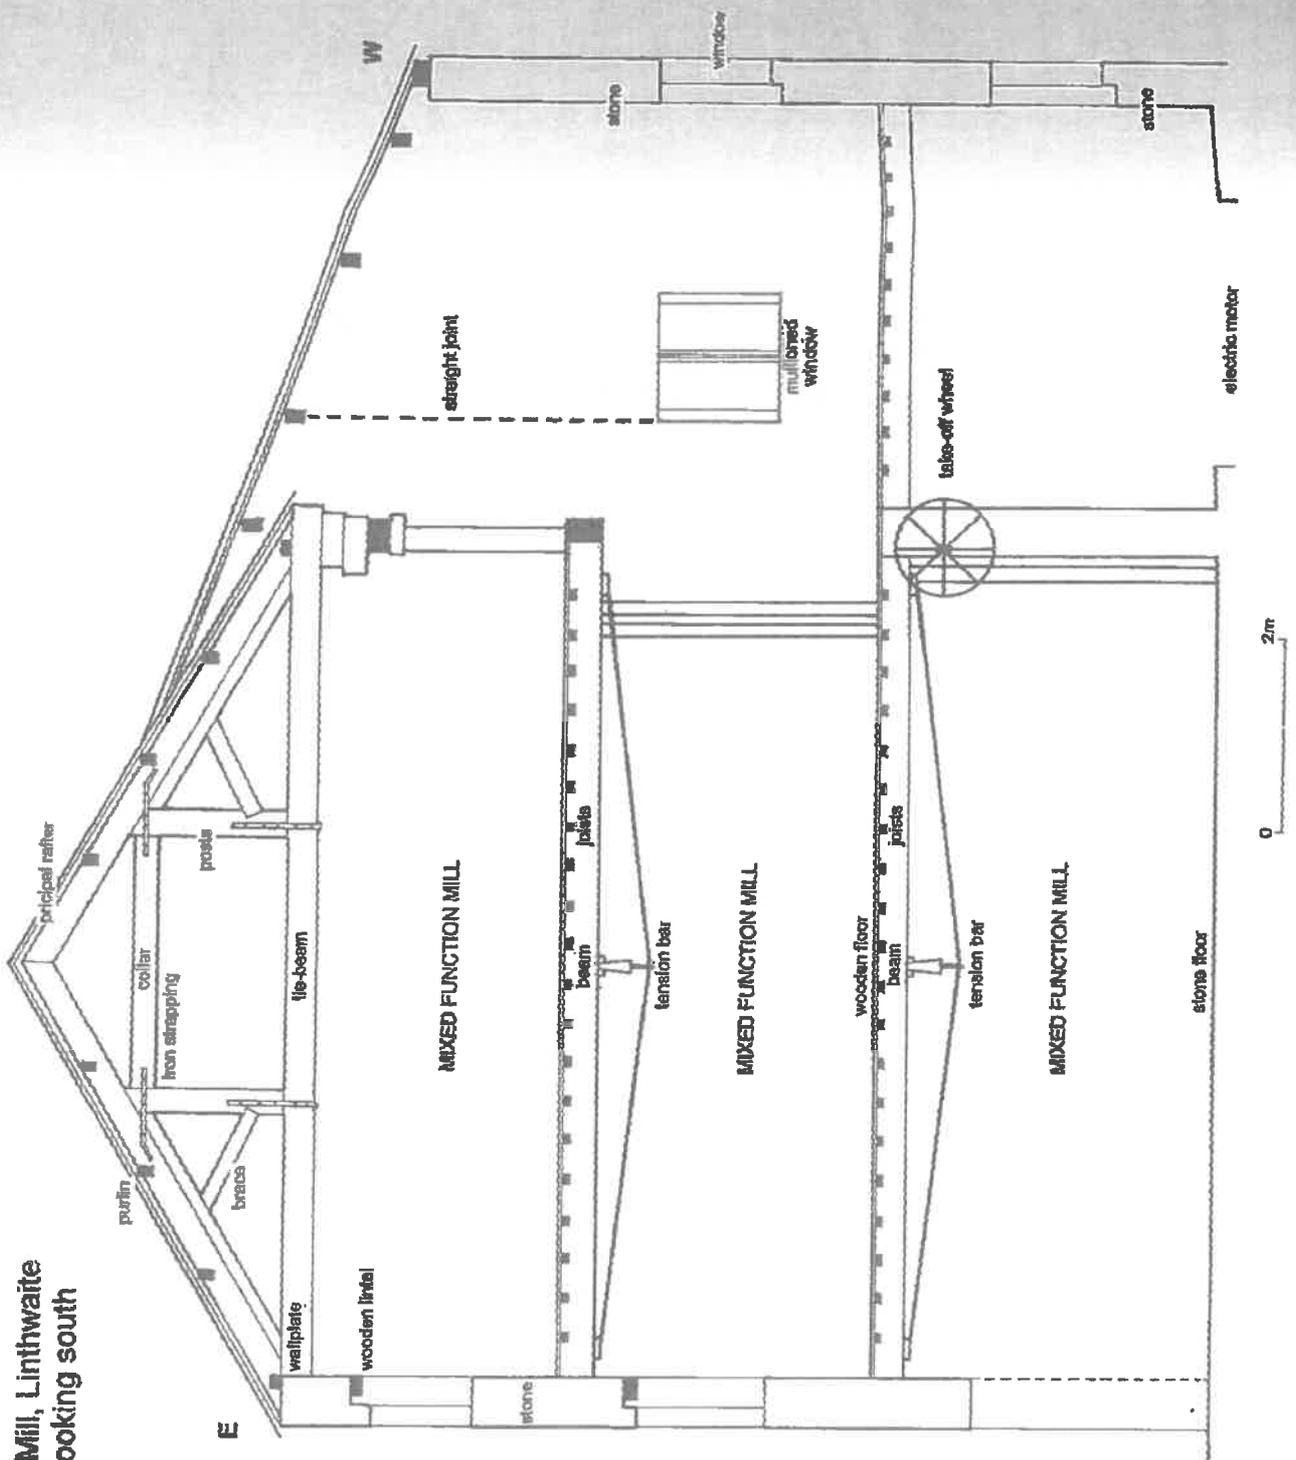
Fig. 19 Section 2

The roof (Fig. 19.) is supported on a series of seven soft-wood trusses. Each consists of a tie-beam supporting two queen posts with joining collar. A raked brace from each post supports a half rafter, which in turn supports the principal rafters which join at the apex without a ridge. Iron strapping is used to reinforce joints in the collar line and at each post. The principal rafters rest on wall plates and support three trenched purlins to each side. The cladding originally was of stone.

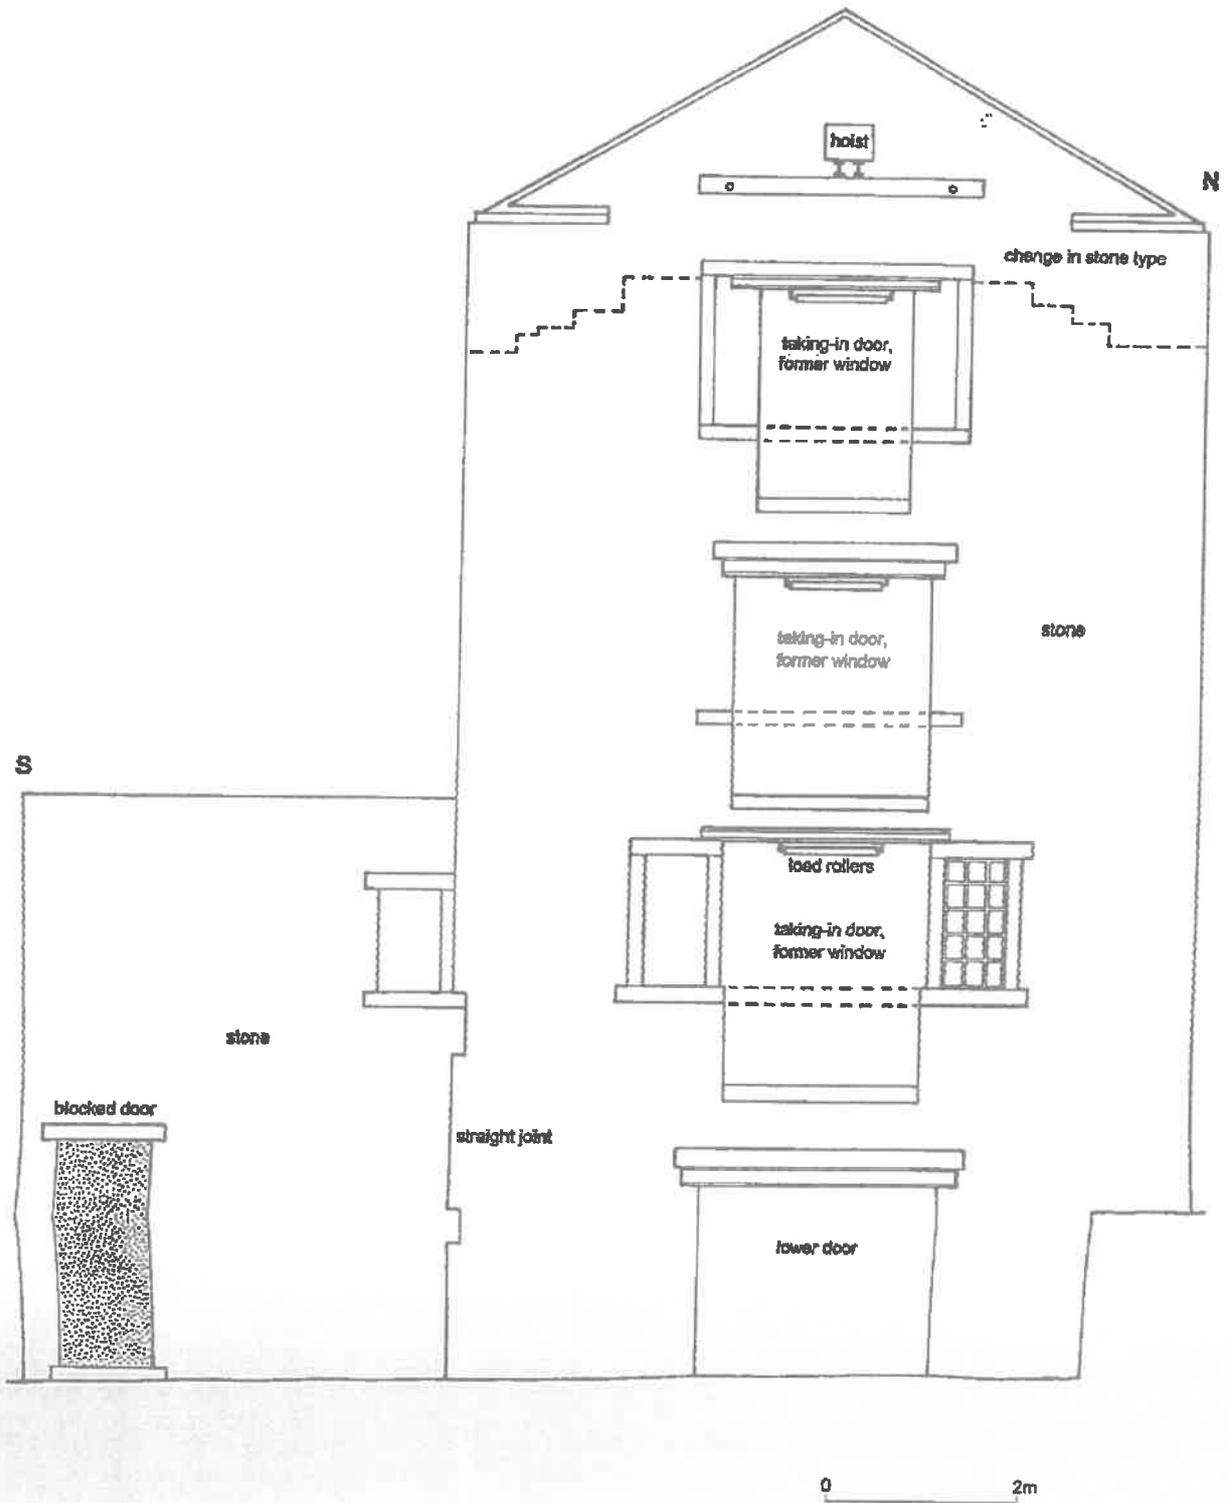
Fig. 32 Elevation 3

The east facing façade (Fig. 32.) has, on its ground floor a wide loading door, possibly of later date. At first floor level, a wide taking in door with load-rollers attached to its steel lintel has been inserted in what may have been a four part mullioned window. The northern part retains its multi pane glazing. The wide taking in door at second floor level may replace a two part mullioned window, and at third floor level, a narrower taking in door replaces a three part taking in door. A hoist projects from the apex of the roof. It is possible that the stone work above the lintel of the top taking in door has been rebuilt. The north facing elevation (Fig. 31.) demonstrates that the land rises to the north. There are no ground floor windows. At first floor level, openings at bays three to six are stone blocked. Tie rod terminals are situated between bays three and four. At second floor level, a wide stone blocked window is situated at bay four, and a multi light window with original glazing at bay seven. Above window head heights are three tie rod terminals. The semi circular projection of the stair tower obscures the first two bays of this building.

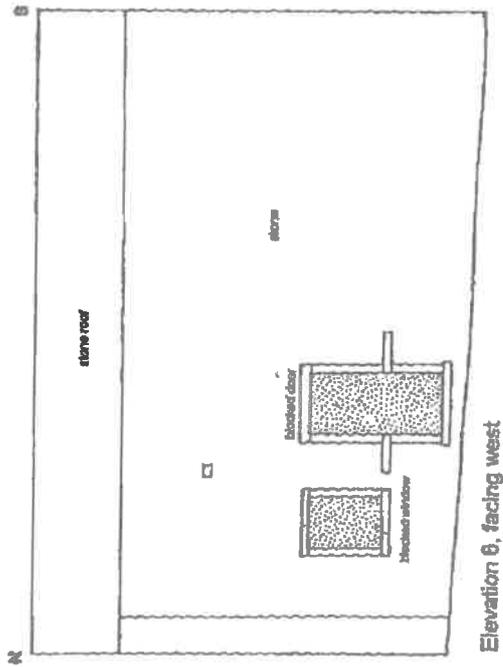
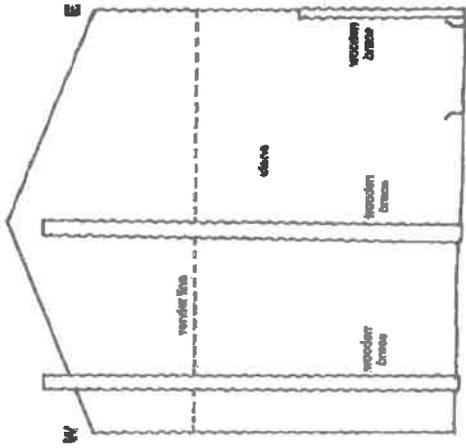
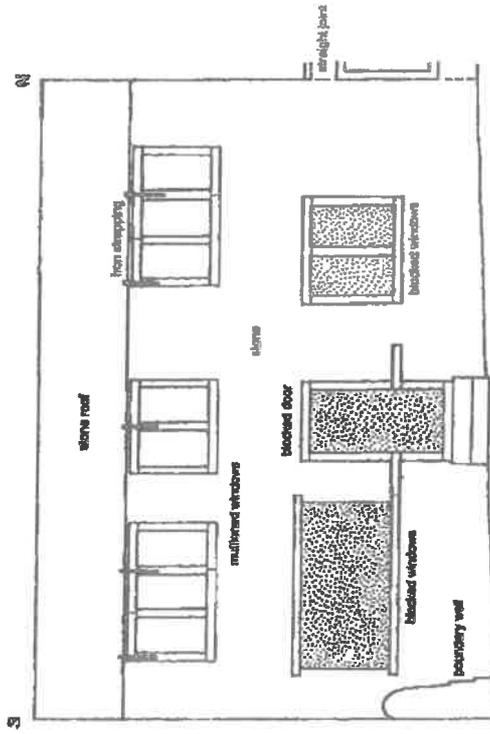
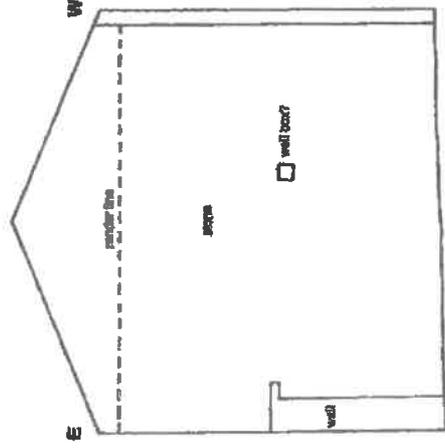
Fig. 35 Elevations 6, 7, 8, & 9

East facing elevation (Fig. 35). The ground floor has a blocked three part mullioned window to the south, and a blocked two part window to the north. In the centre is a stone blocked door with two steps up. At first floor height two three part mullioned windows flank a central two part one. All are open but have lost their glazing. Iron strapping has been used to repair the windows. The roof, of stone, survives. North facing elevation. Part rendered, generally plain, gable all. Pitch of the roof is remarkably shallow. West facing elevation. Rough coursed stone. Interrupted to the north by a stone blocked door and window. South facing elevation. Partly obscured by recent wooden buttresses designed to prevent further movement of the bowing wall. The elevation is part rendered and generally featureless.
